UM-3736-98
1998 Acura Integra

In-depth Vehicle Occupant Report

The University
of Michigan
Transportation
Research Institute

Case Vehicle (A): 1998 Acura
 Type: Integra, 2-door coupe
 Driver: 20-year-old male
 CDC: 01-FDEW-2

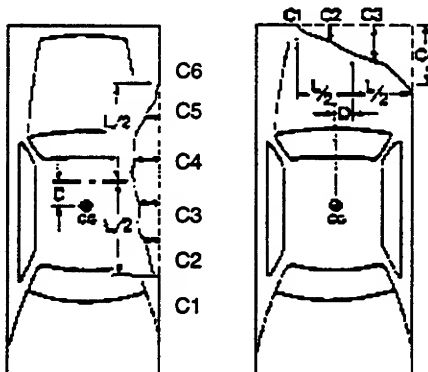
Specific Impact No.	Location of Direct Damage	Location of Field L
1	Begin (5) front bumper corner	B.C. to B.C.

DL 113
UDL 25
